St. Theresa Parish

Building Envelope Assessment May 2016

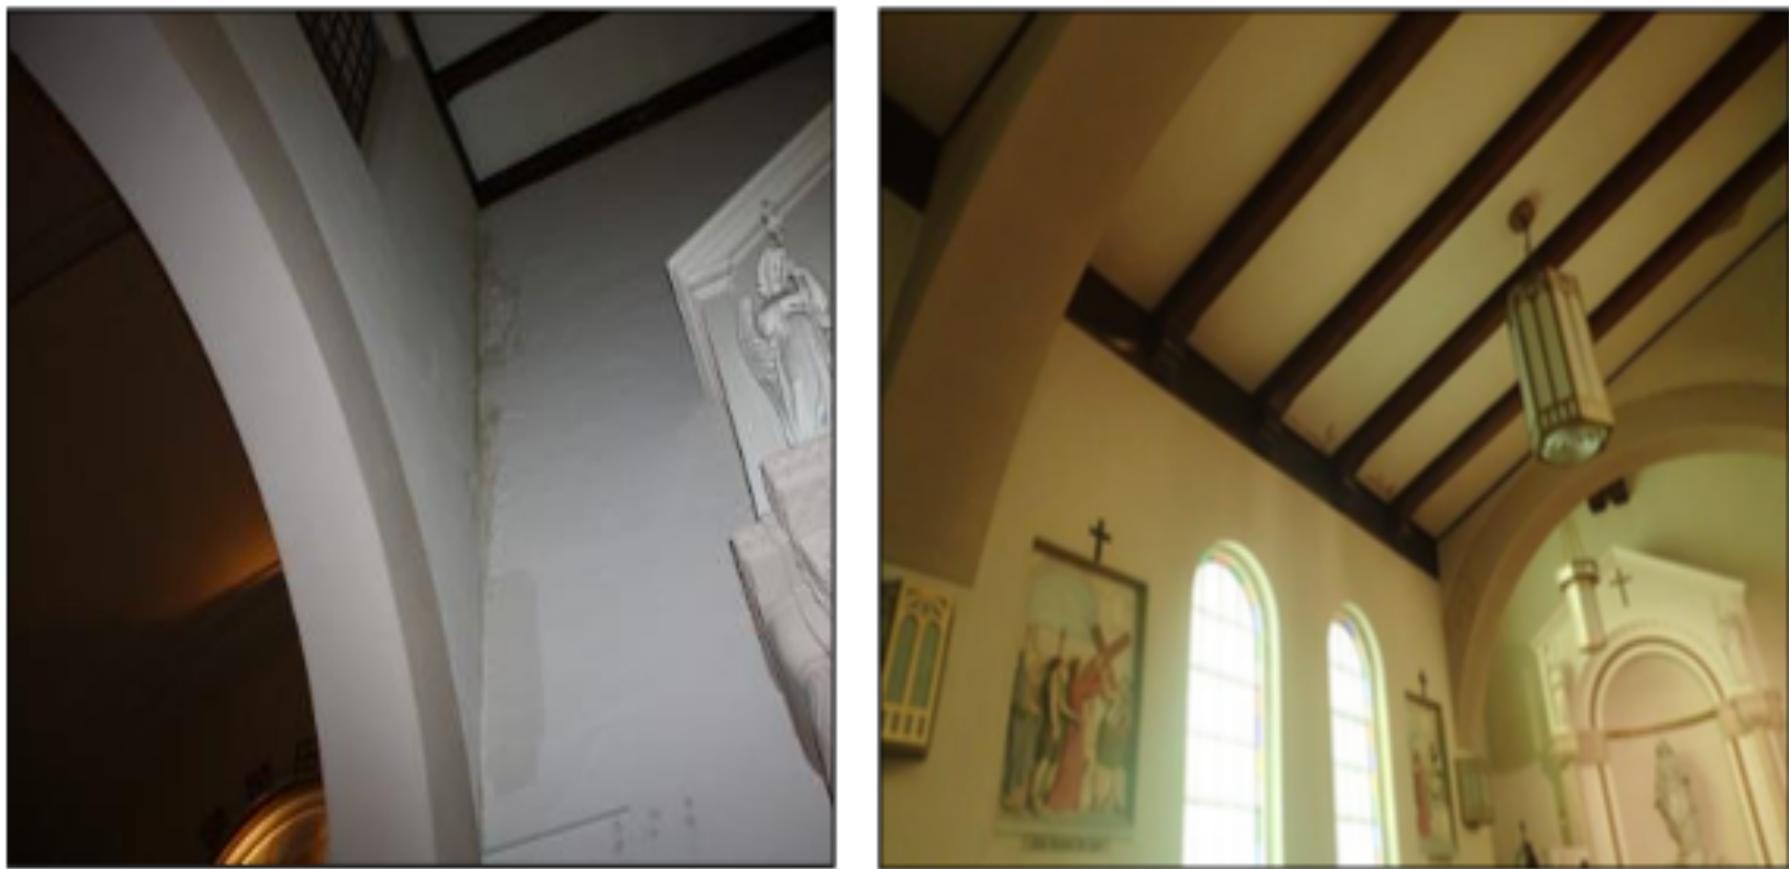
Photo 1: Water staining on interior finishes [JCAL 2016]

Photo 2: Water staining on interior finishes [JCAL 2016]

• Repair and paint interior finishes

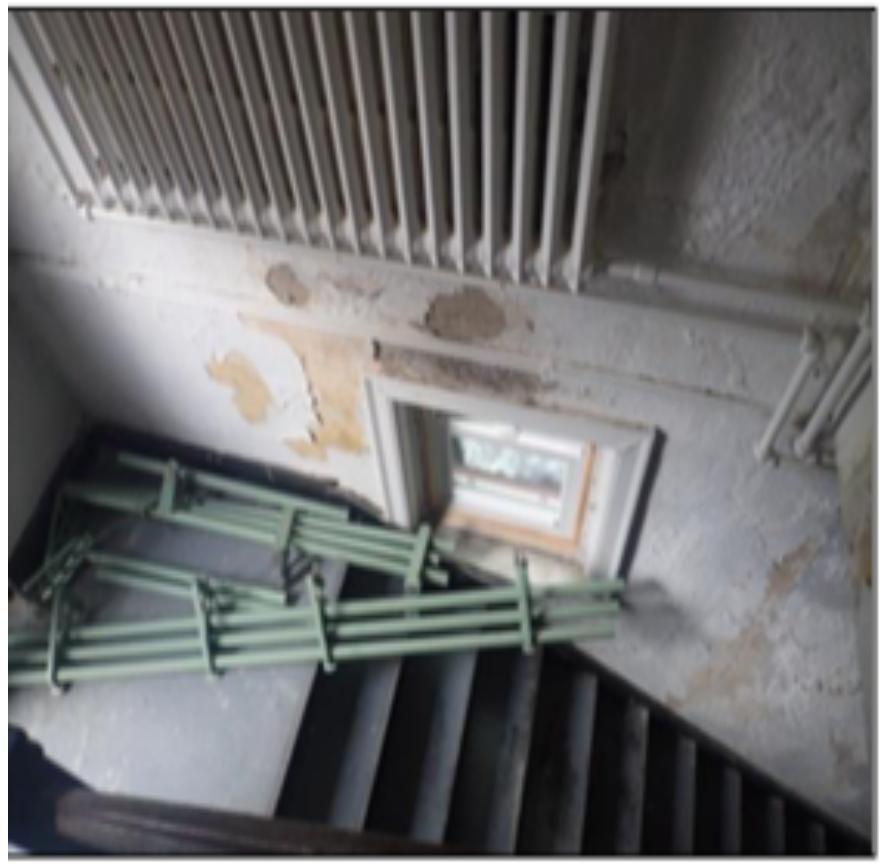
Photo 3: Peeling paint and musty smell inside north-east staircase [JCAL 2016]

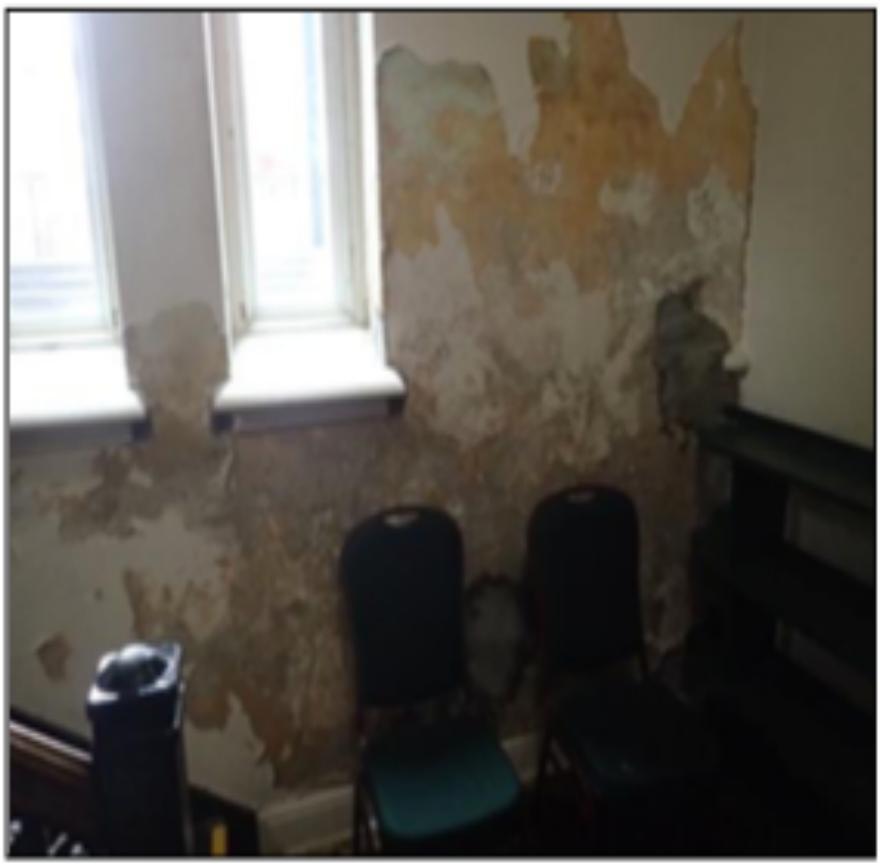
Photo 4: Peeling paint and musty smell inside northeast staircase [JCAL 2016]

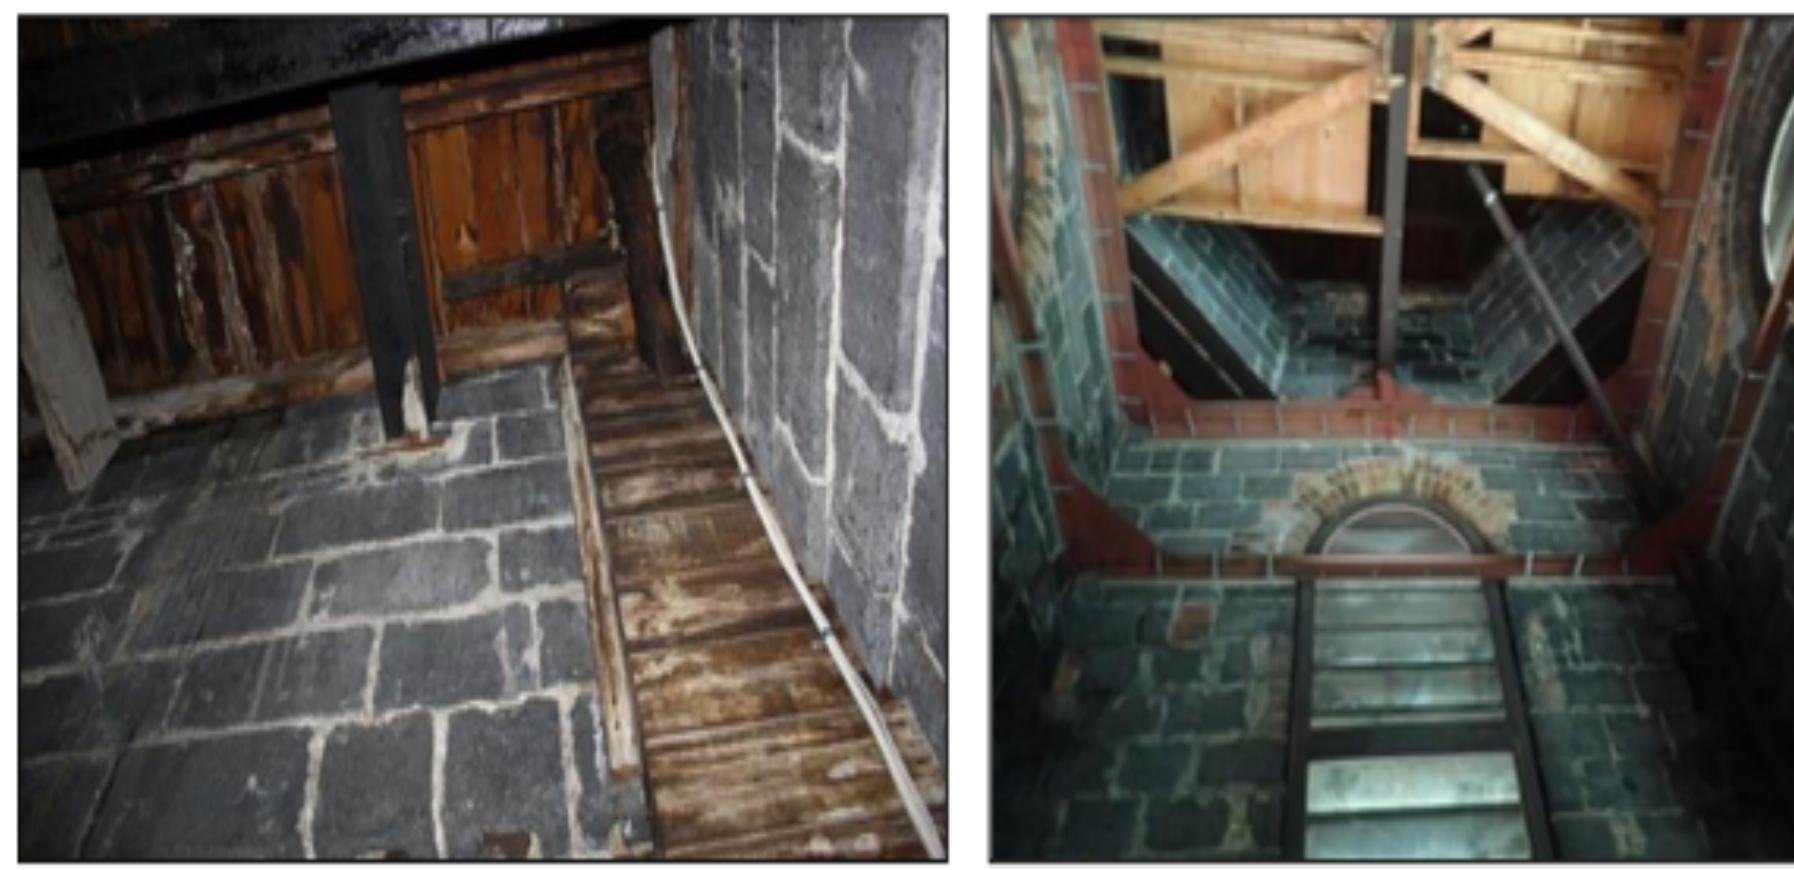
Photo 5: Water staining on interior finishes [JCAL 2016]

Photo 6: Water staining on interior finishes [JCAL 2016]

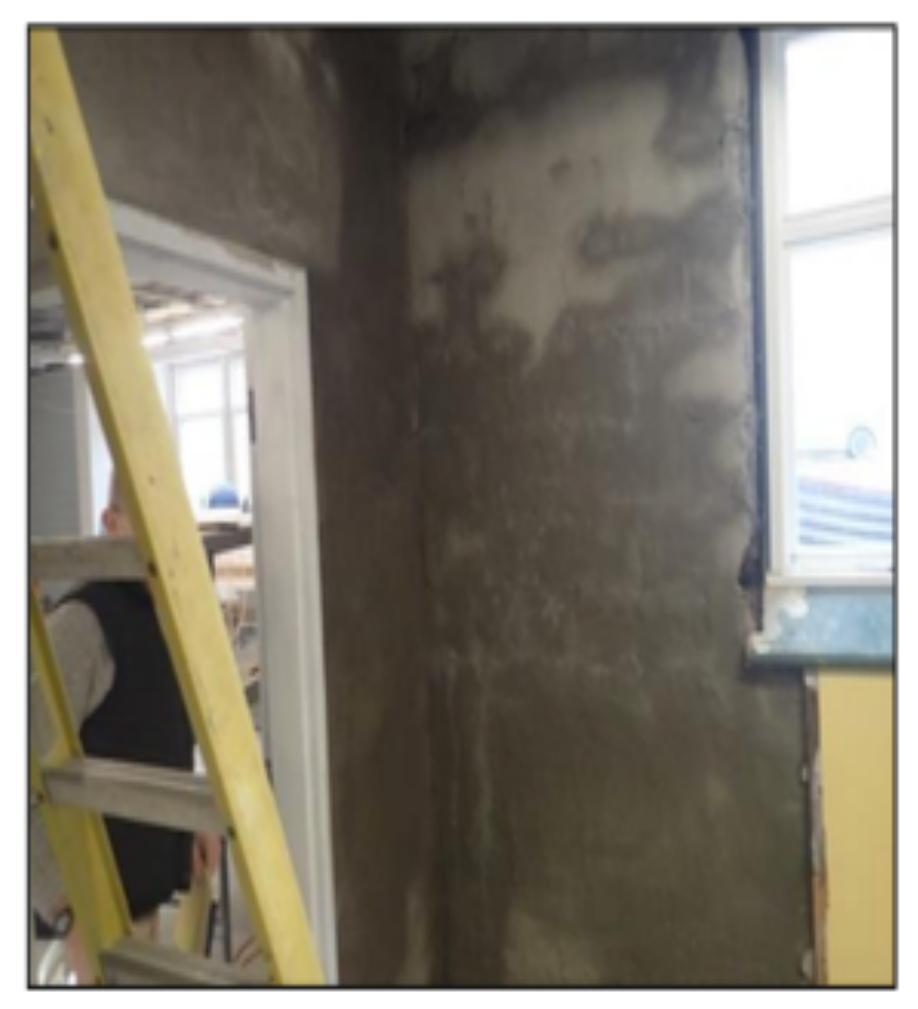
Photo 7: Damp walls during the basement renovation [JCAL 2016]

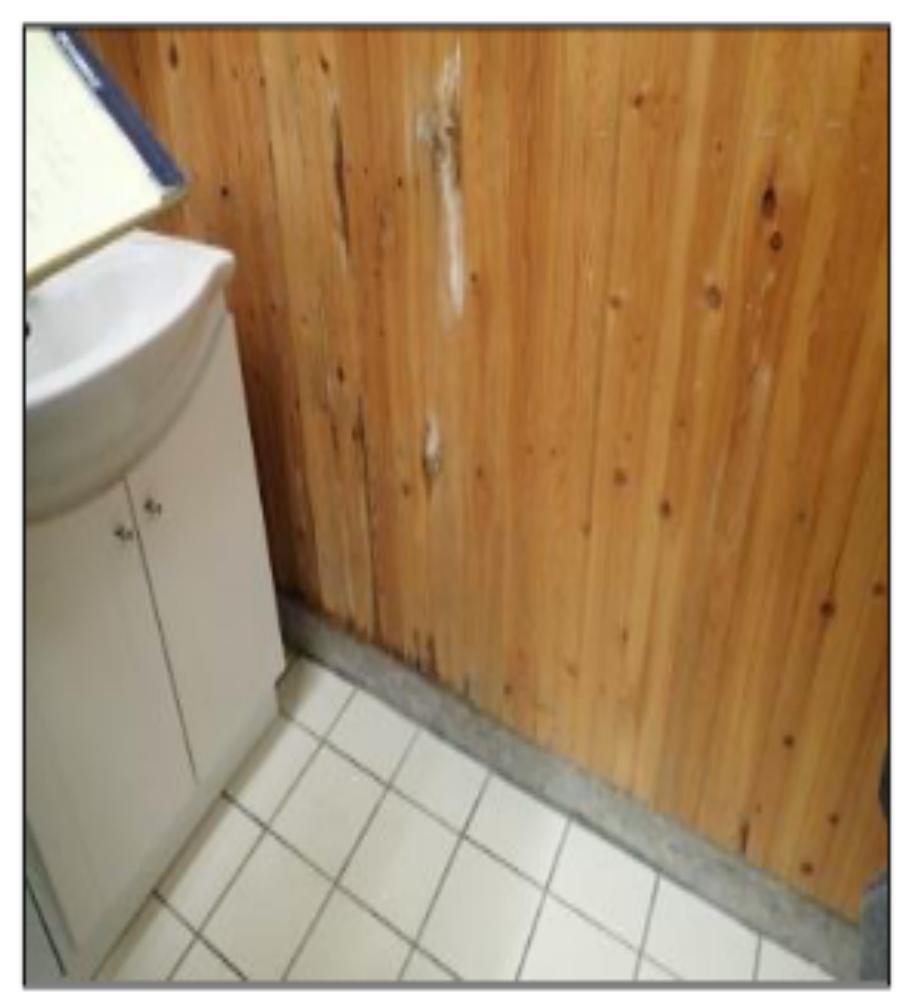
Photo 8: Water staining on interior finishes [JCAL 2016]

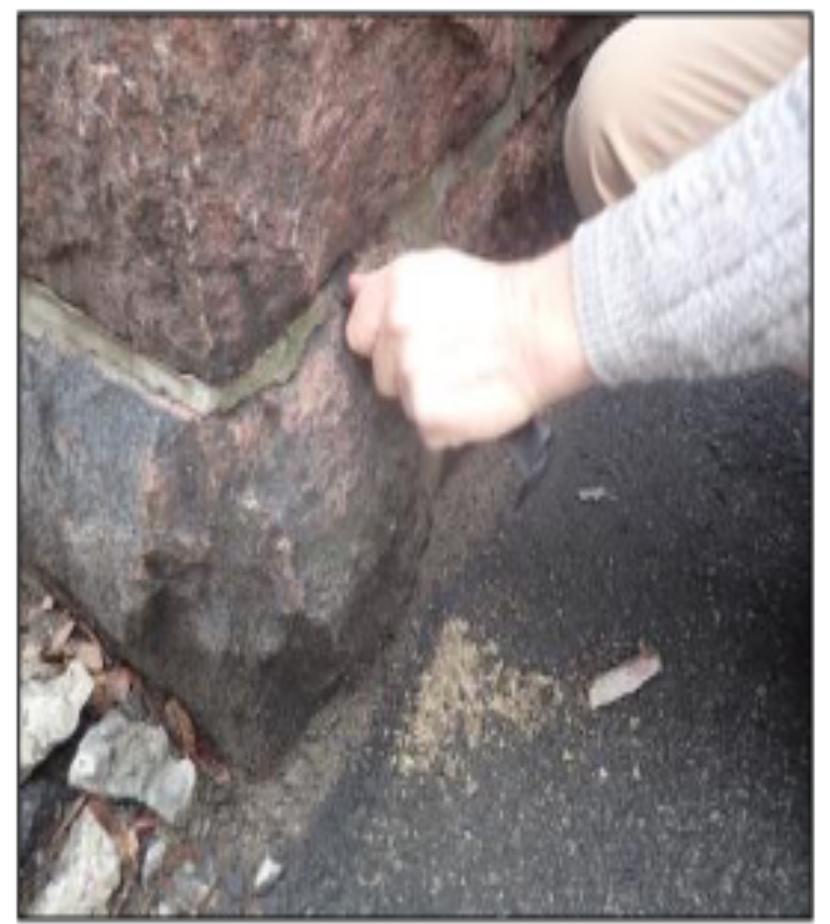
Photo 9: Soft, sandy mortar behind an outer layer of hard cement based mortar [JCAL 2016]

- Proper grouting is required to repair mortar joints
- Parapet just east of north-east entrance has shifted 10 mm but appears to be stable
- Parging installed in lieu of stone (north & east elevations)...some areas of de-bonding & cracking
- Main entrance deteriorated mortar joints below windows and along perimeter of the wall

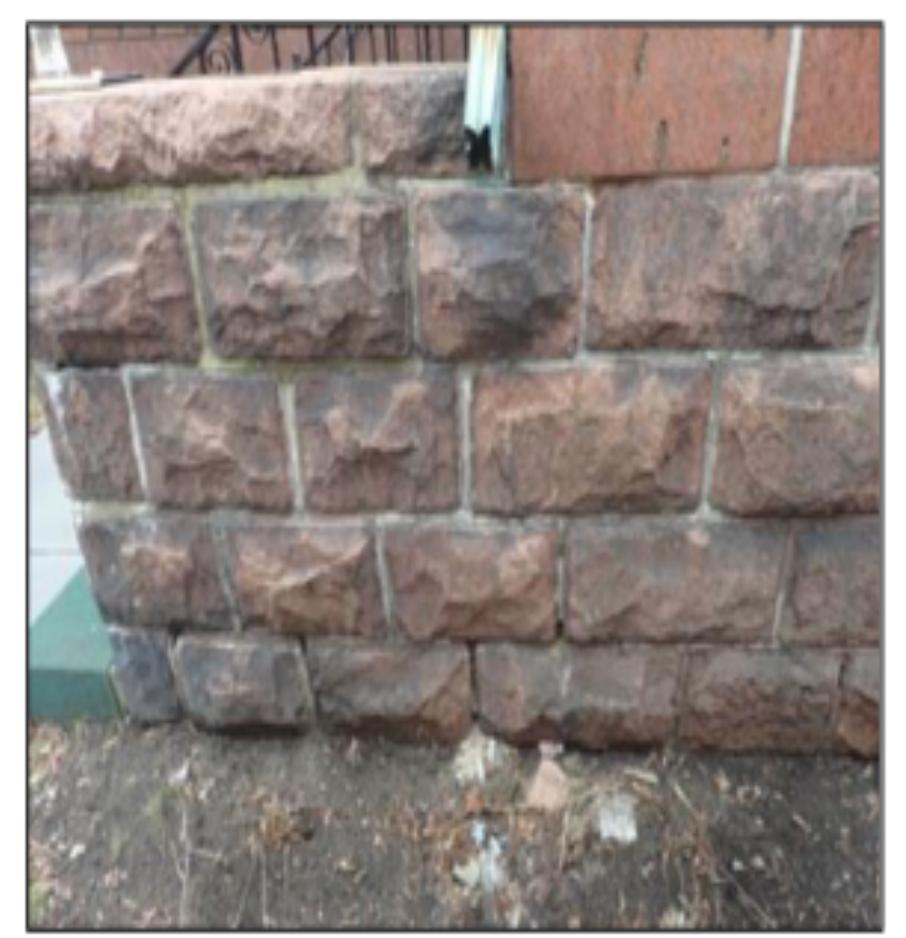
Photo 10: Debonded joints, efflorescence, and sandy joints are typical in the stone masonry [JCAL 2016]

• Repair the deteriorated stone and brick joints

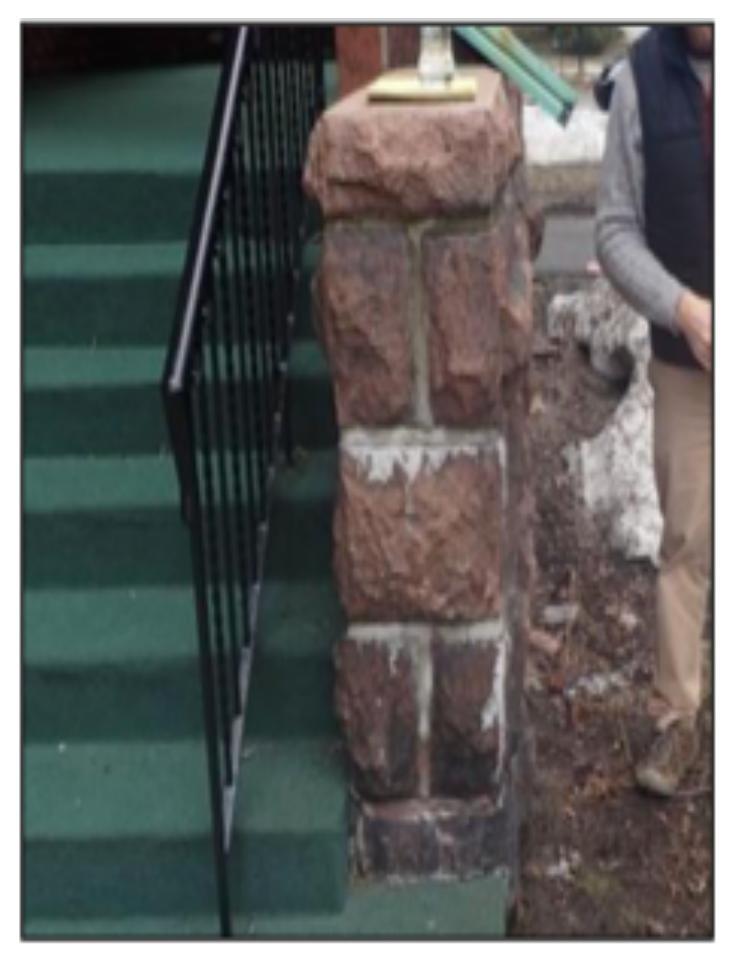
Photo 11: Debonded joints, efflorescence, and sandy joints are typical in the stone masonry [JCAL 2016]

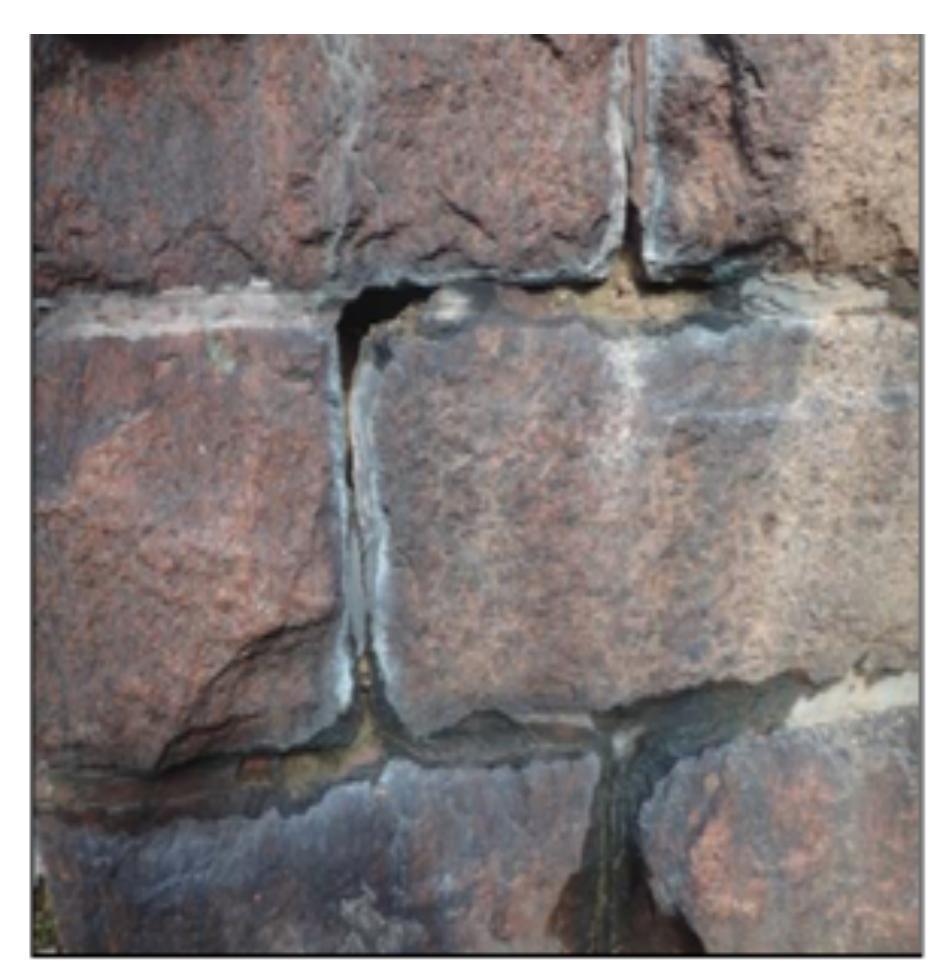
Photo 12: South elevation, the worst area of mortar deterioration. No mortar remains in the joint. [JCAL 2016]

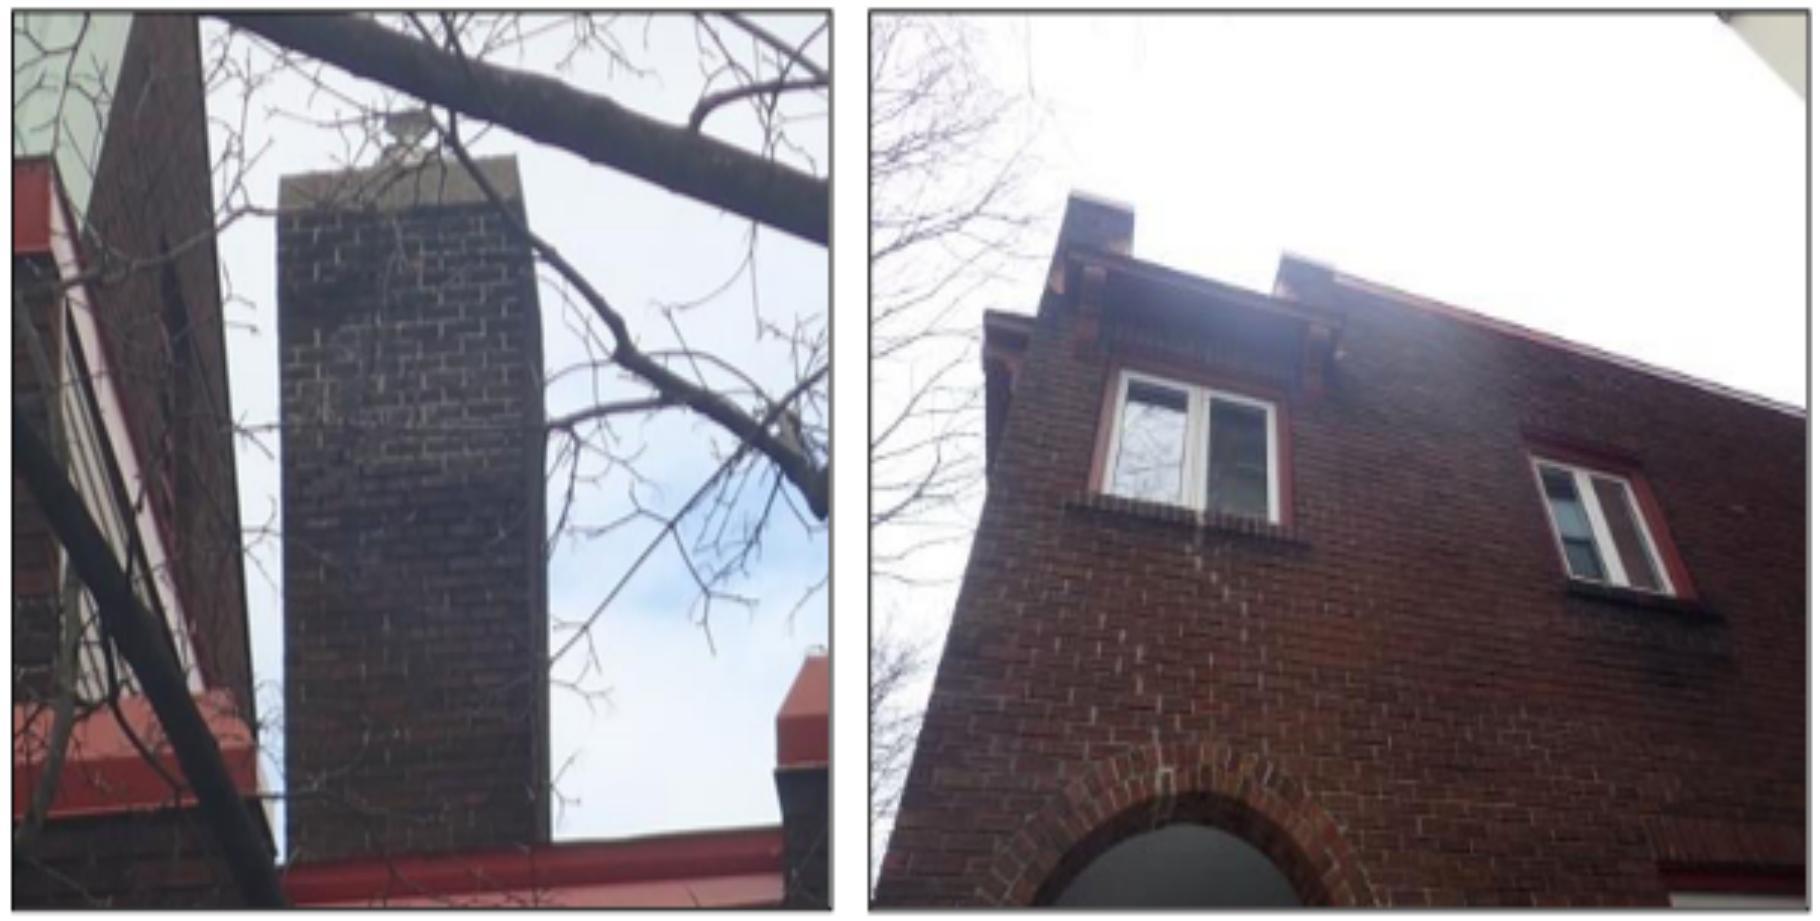
Photo 13: Eroded mortar joints on the chimney [JCAL 2016]

Photo 14: Previous masonry repairs above the brick arch [JCAL 2016]

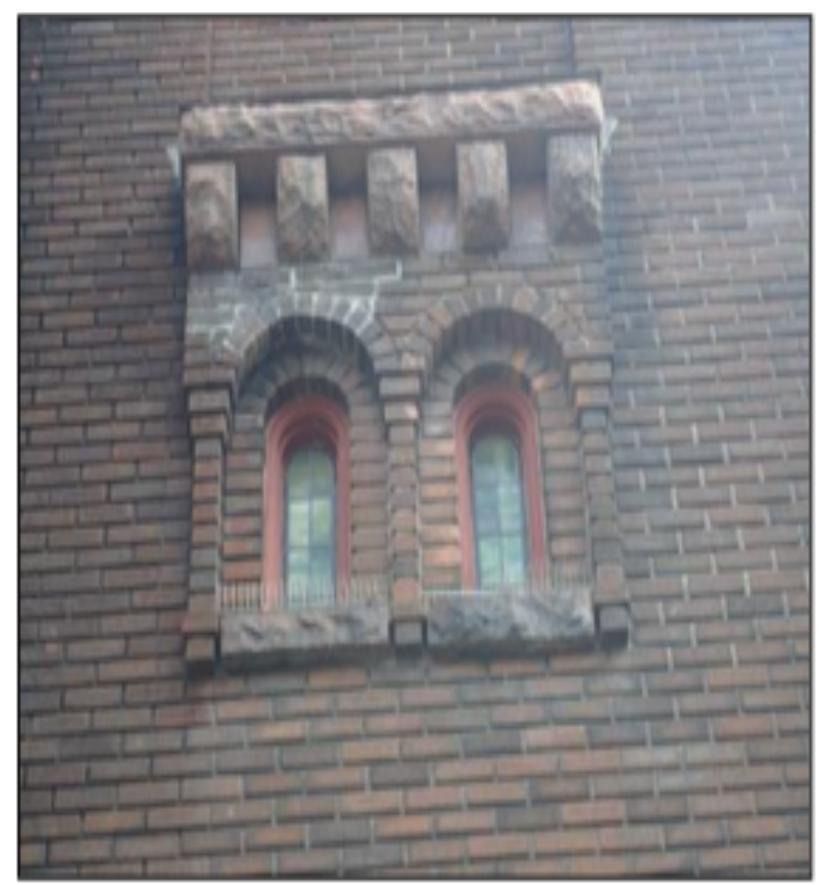
Photo 15: Caulking used to repair deteriorated mortar joints [JCAL 2016]

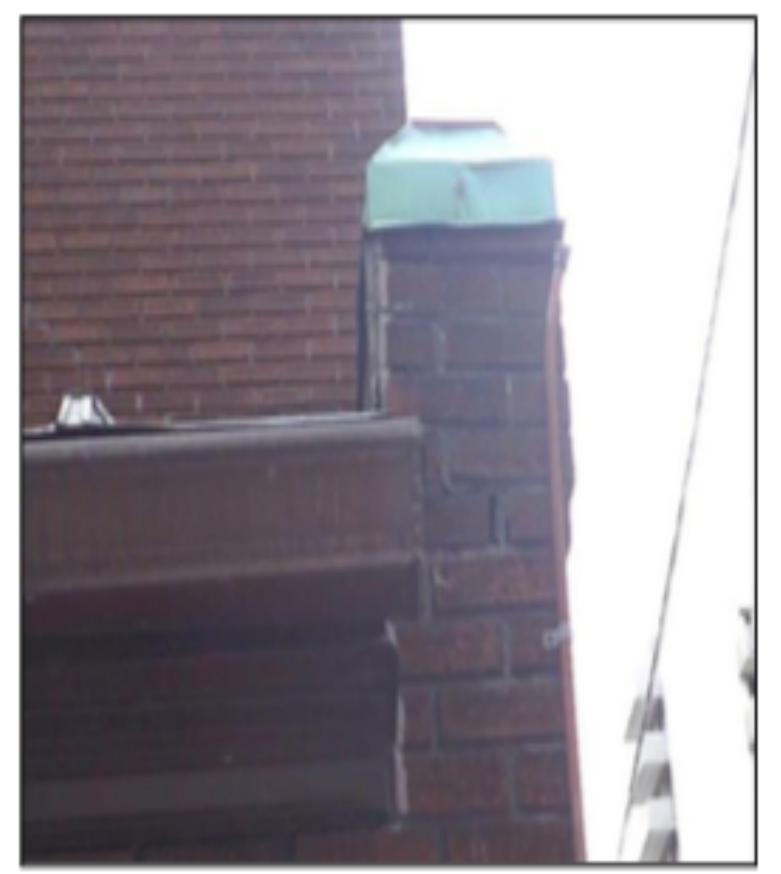
Photo 16: Parapet at north-east corner has shifted [JCAL 2016]

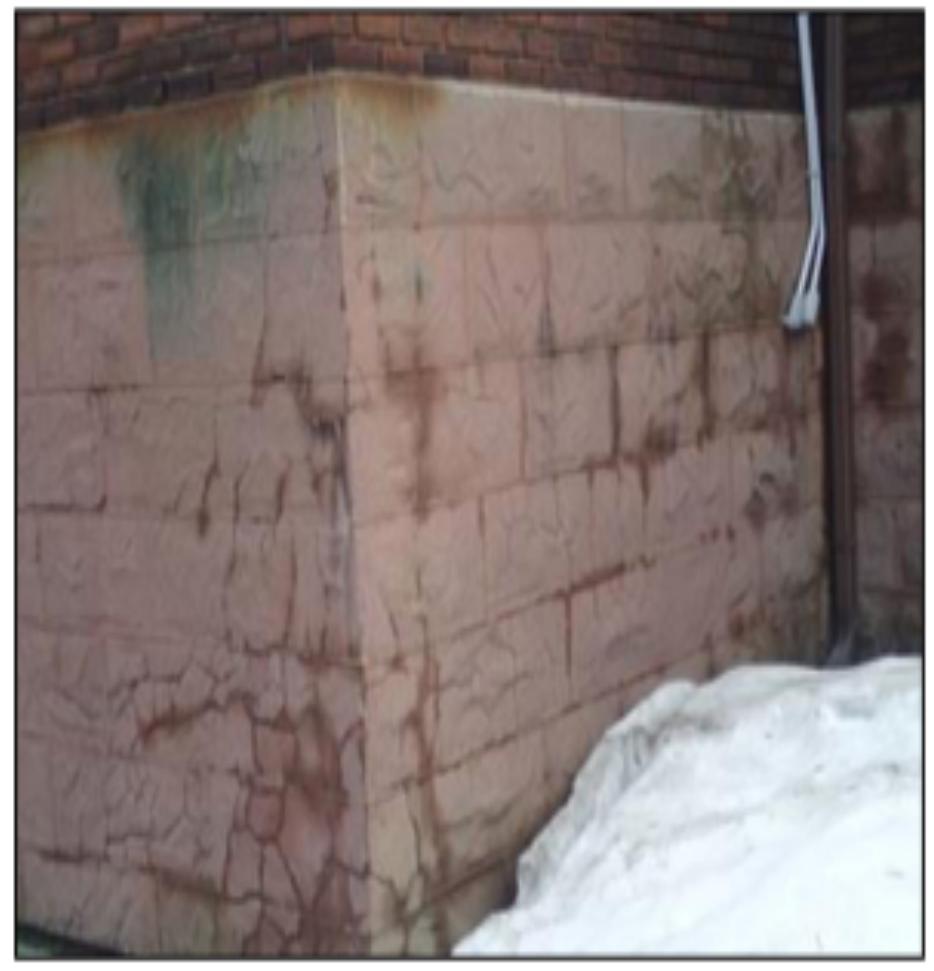
Photo 17: Cracks in parging along north wall [JCAL 2016]

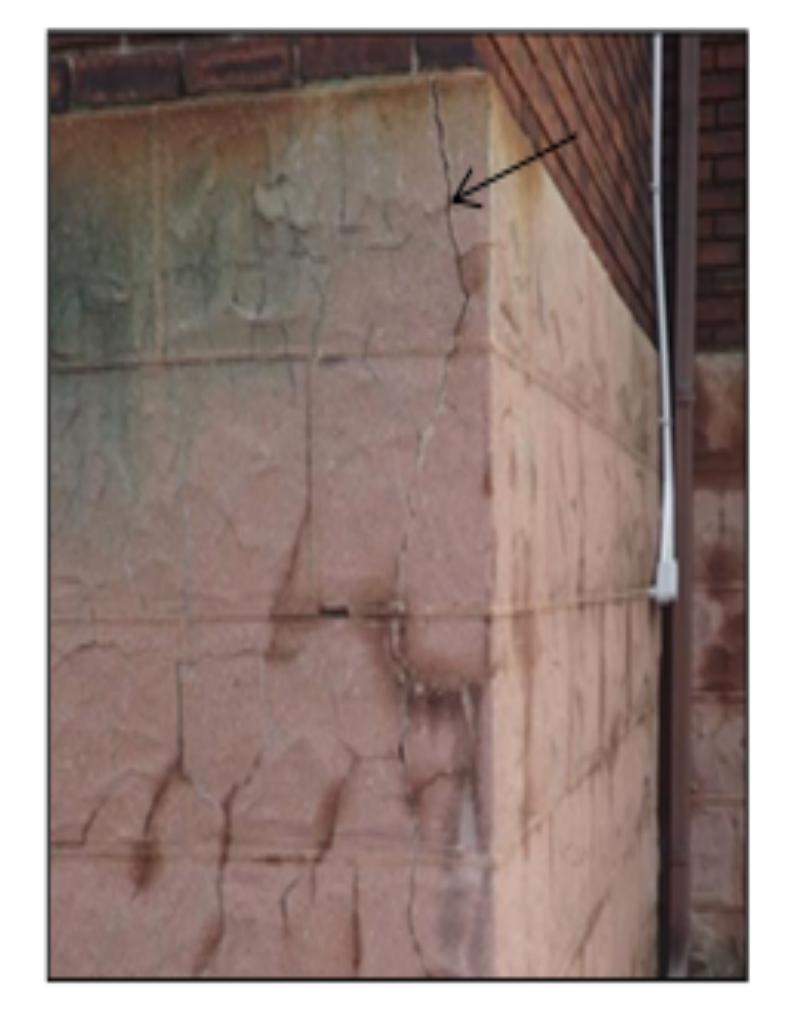
Photo 18: Crack in parging along north wall [JCAL 2016] 17

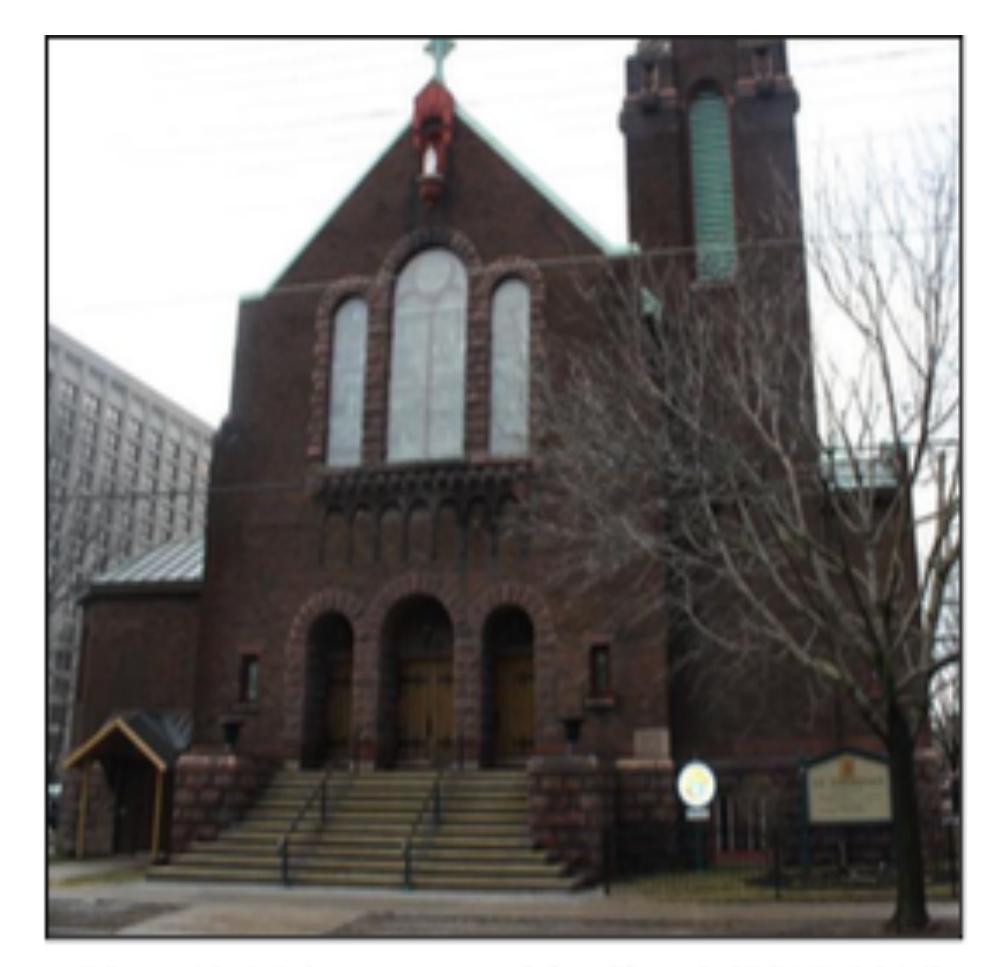
Photo 19: Main entrance of the Church [JCAL 2016]

• Refinish the church doors and caulking

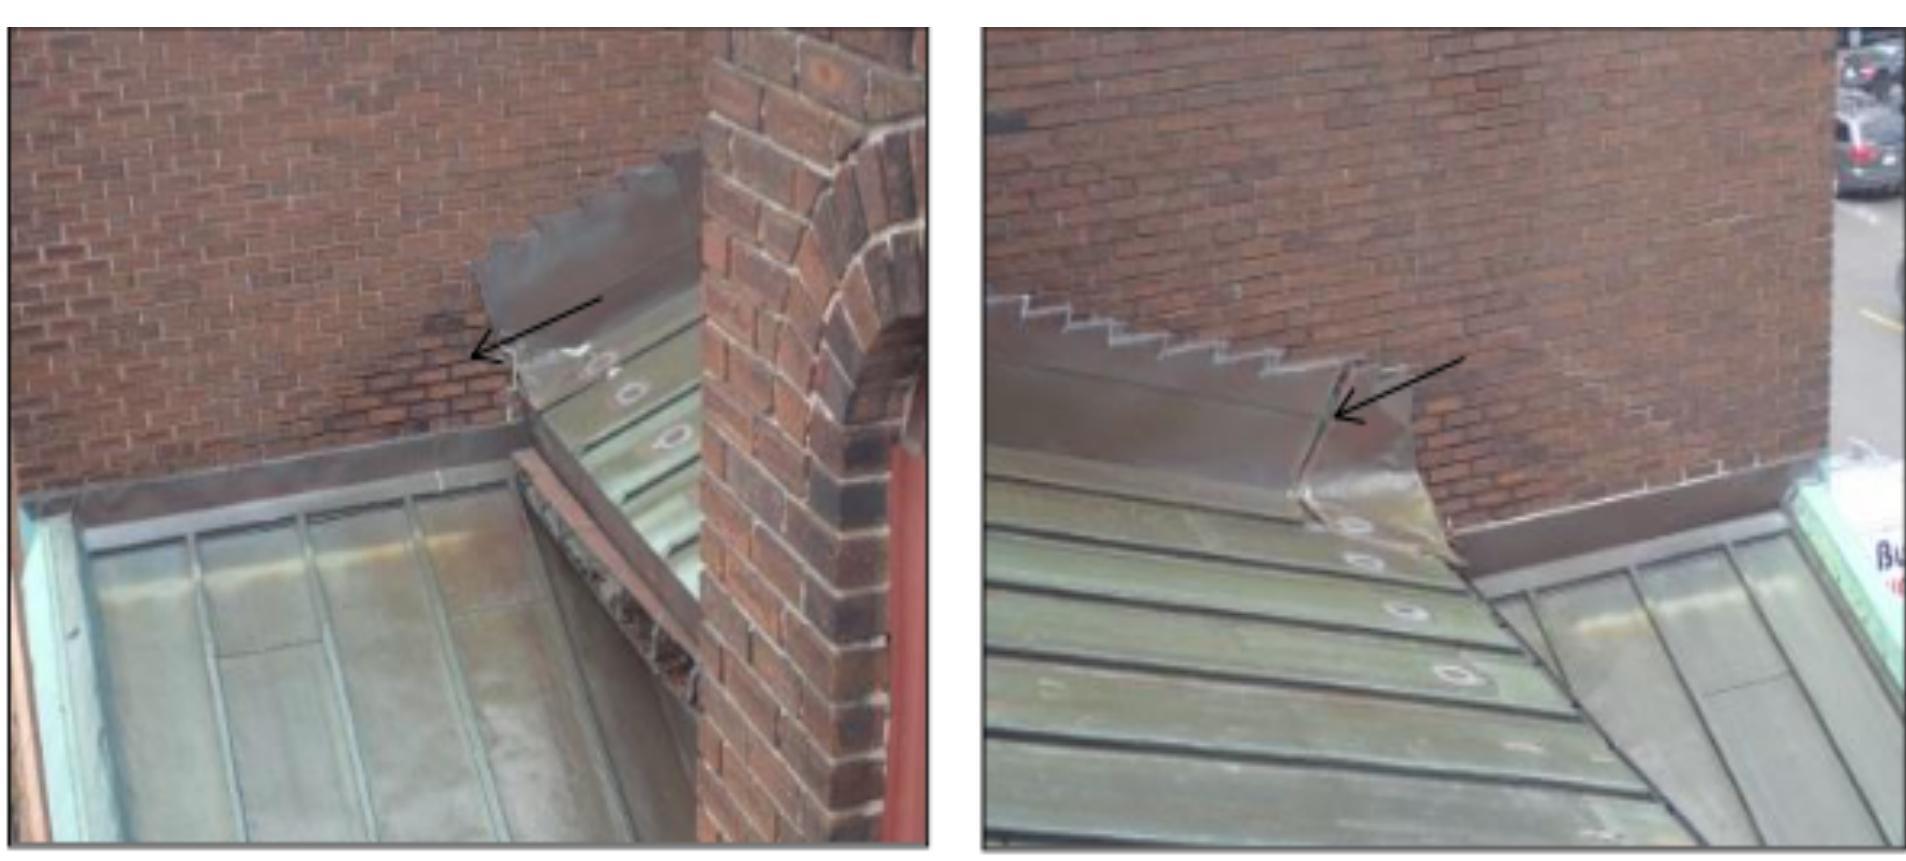
Photo 20: Deteriorated masonry joints due to inadequate cricket [JCAL 2016]

Photo 21: Damaged cricket [JCAL 2016]

• Improve the roof shedding capabilities

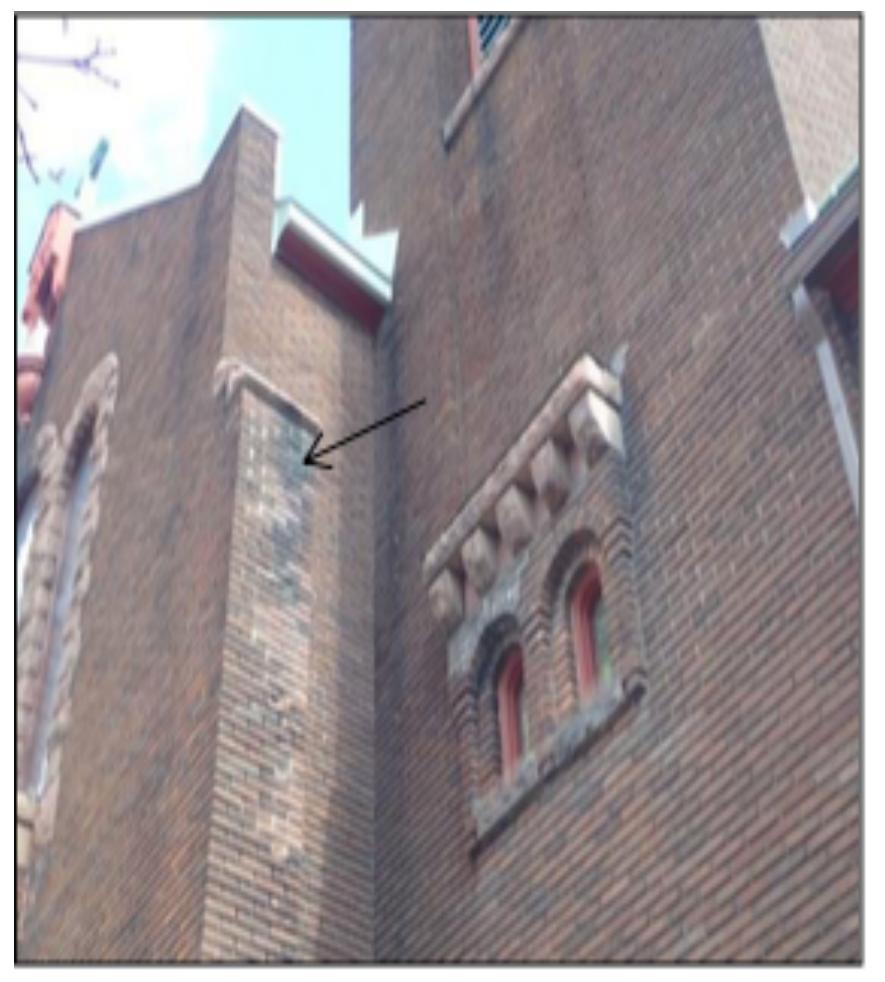
Photo 22: Previous brick repairs and deteriorated mortar joints due to inadequate drainage from roof [JCAL 2016]

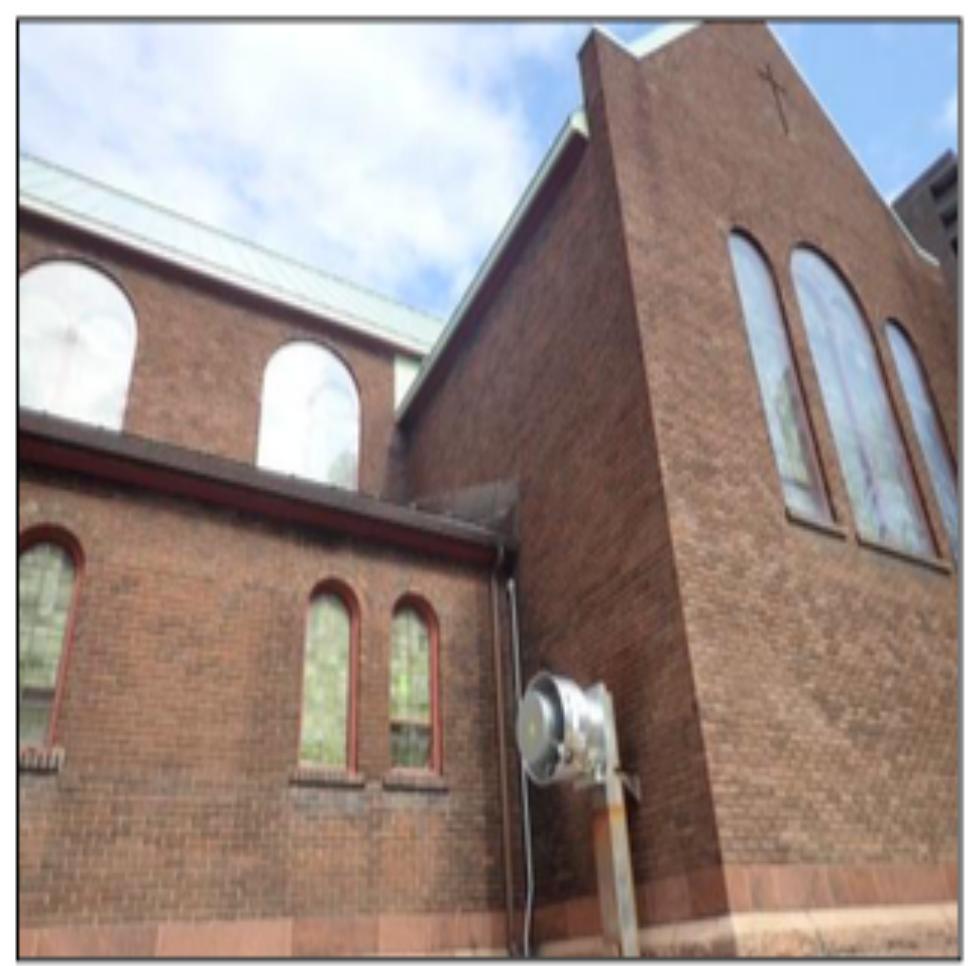
Photo 23: Ventilation unit at risk of damage from falling snow and ice [JCAL 2016]

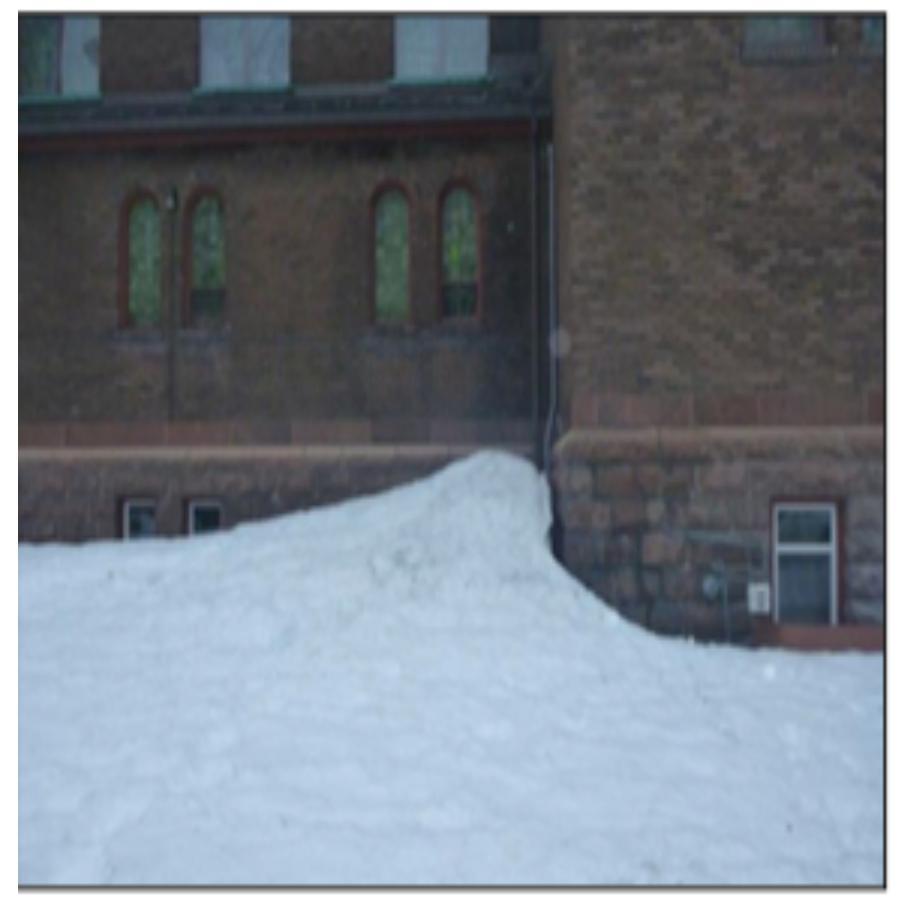
Photo 24: Snow build-up along south elevation [JCAL 2016]

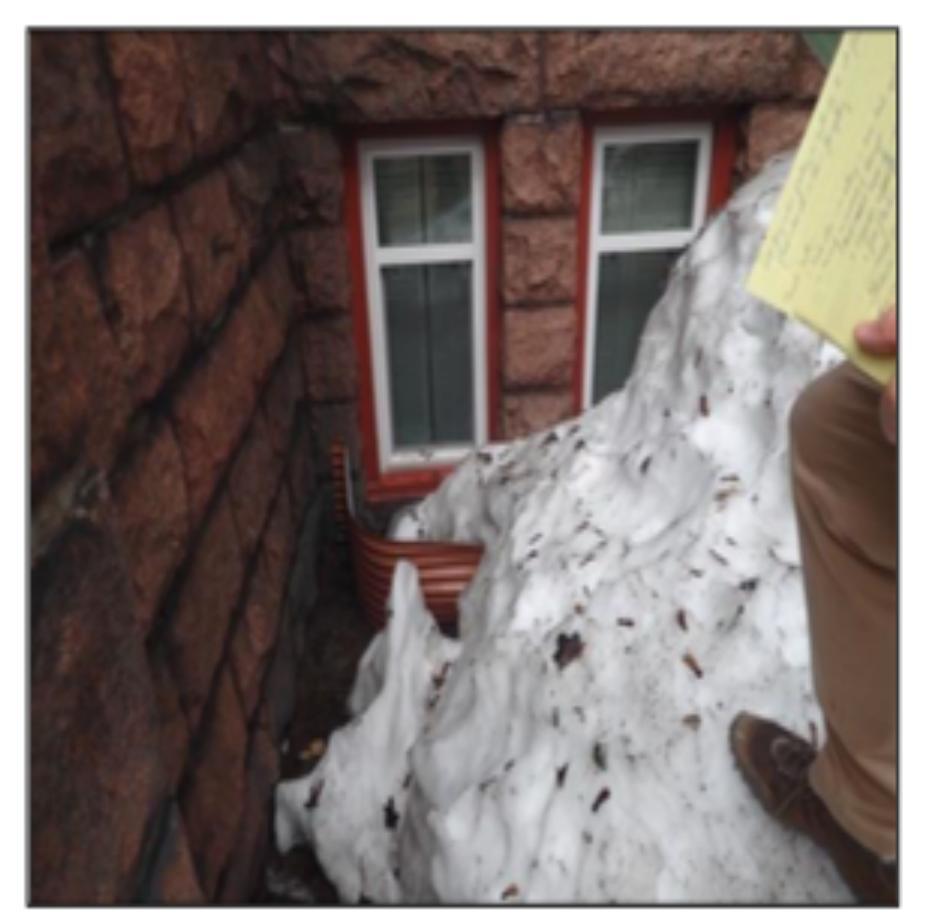
Photo 25: Snow build-up along south elevation [JCAL 2016] 22

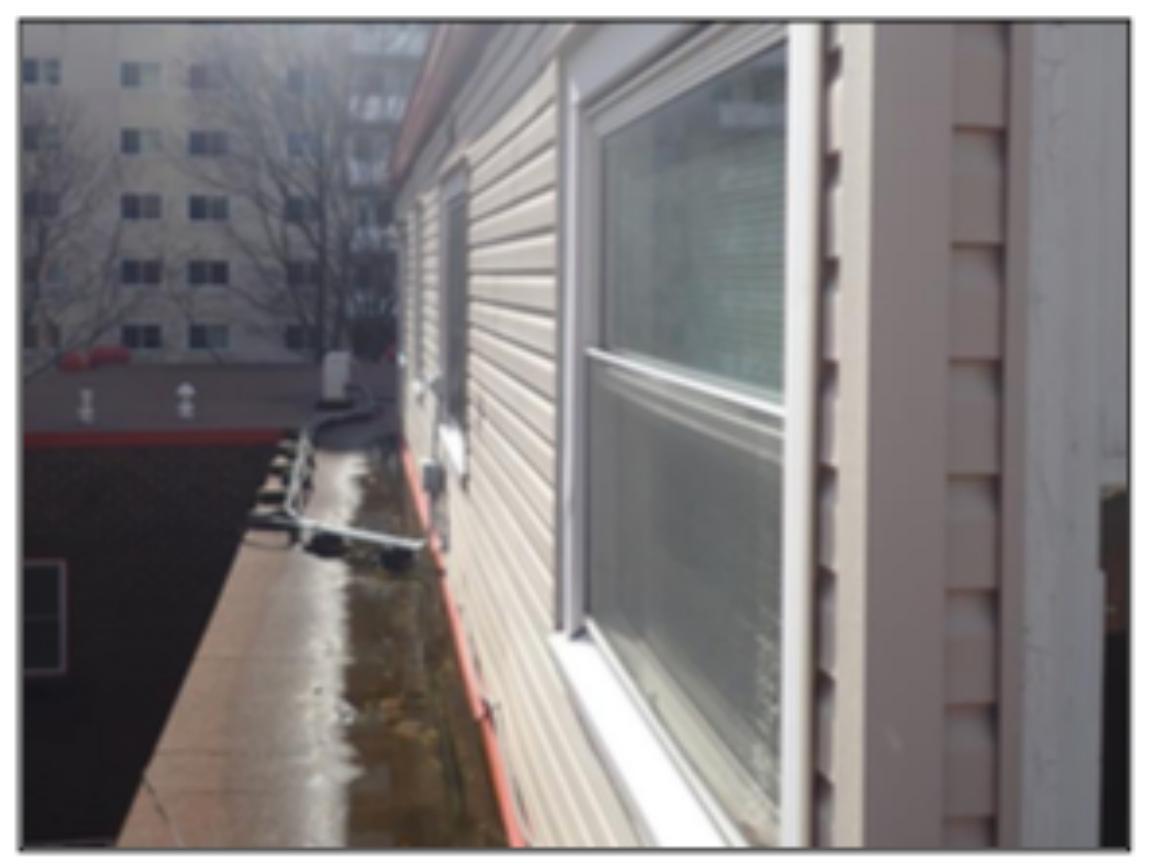
Photo 26: Water ponding on roof of rectory due to incorrect roof slope [JCAL 2016]
