St. Theresa Parish

Building Envelope Assessment May 2016

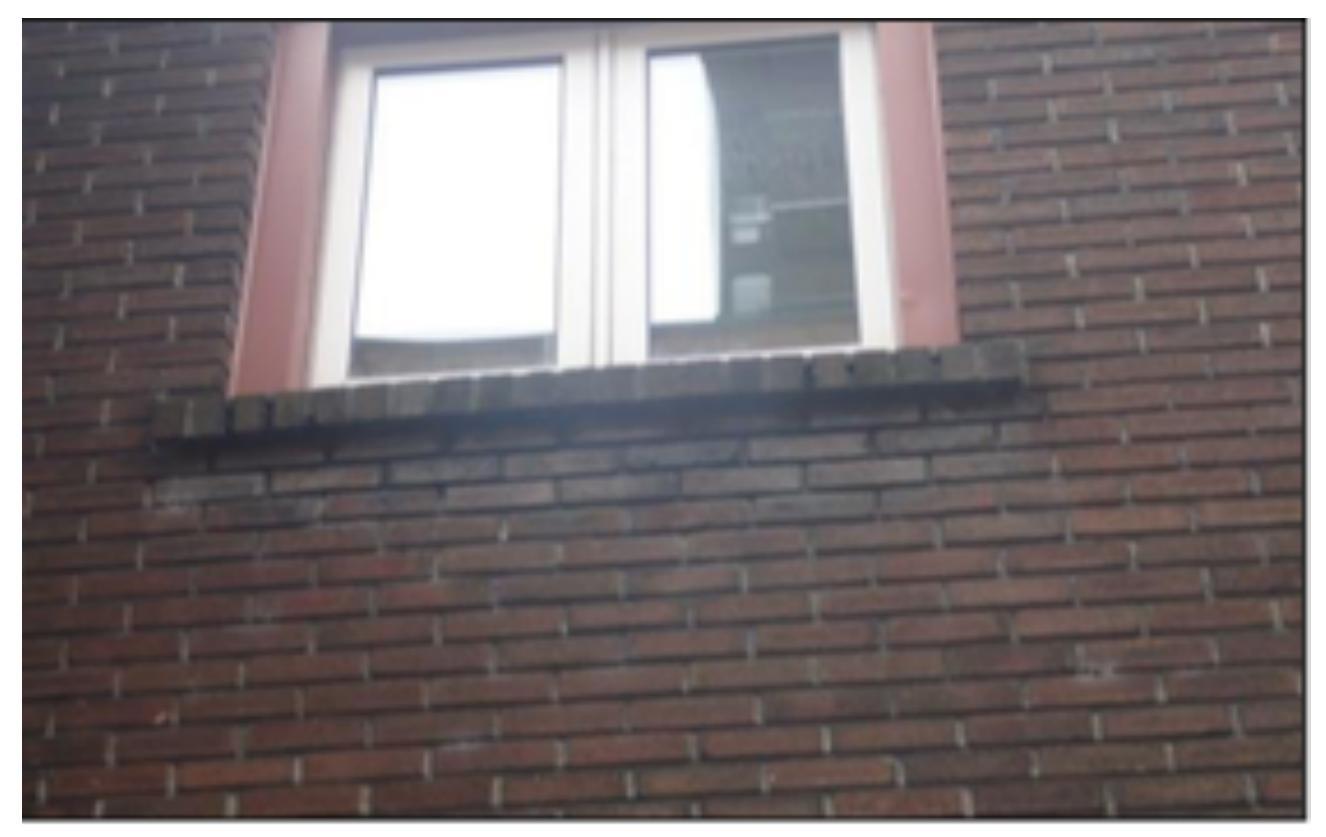
Photo 27: Deterioration and efflorescence below typical window [JCAL 2016]
